# Walk Around

## Focke-Wulf Fw 190A/F

Walk Around Number 22  
squadron/signal publications

By Malcolm Laing and E. Brown Ryle

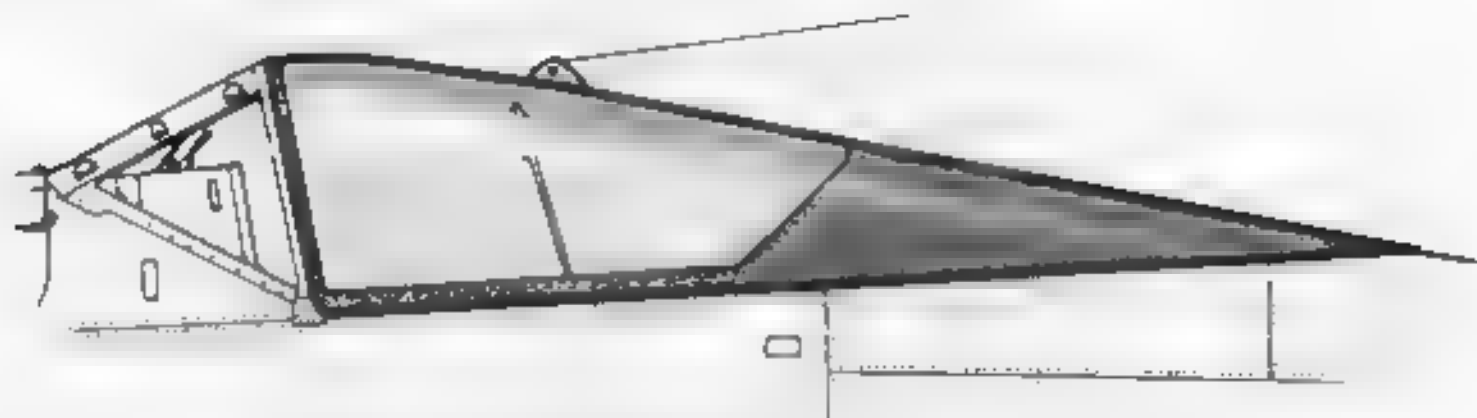
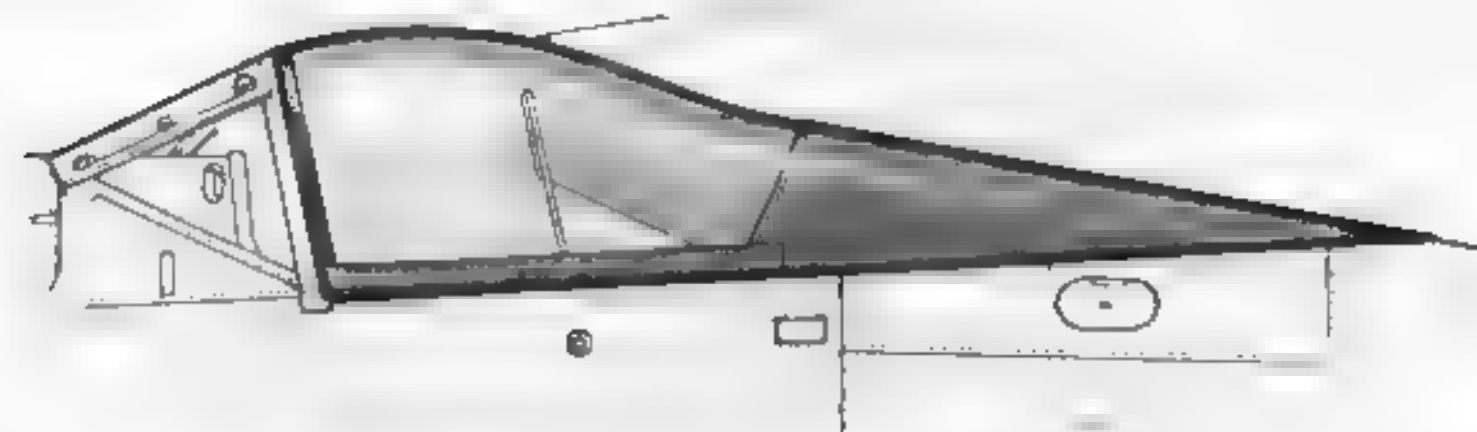
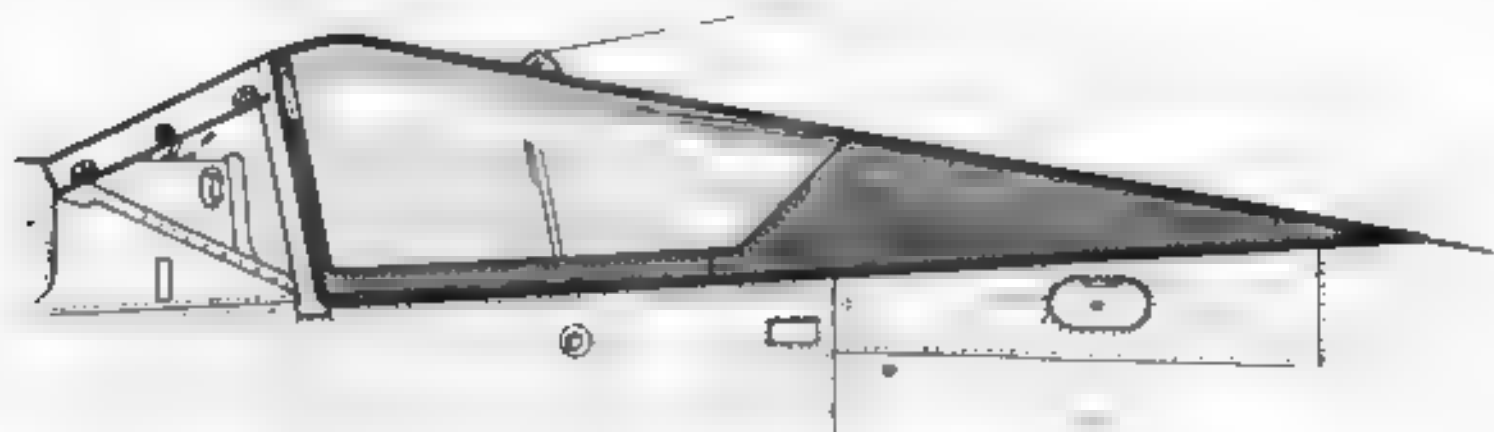
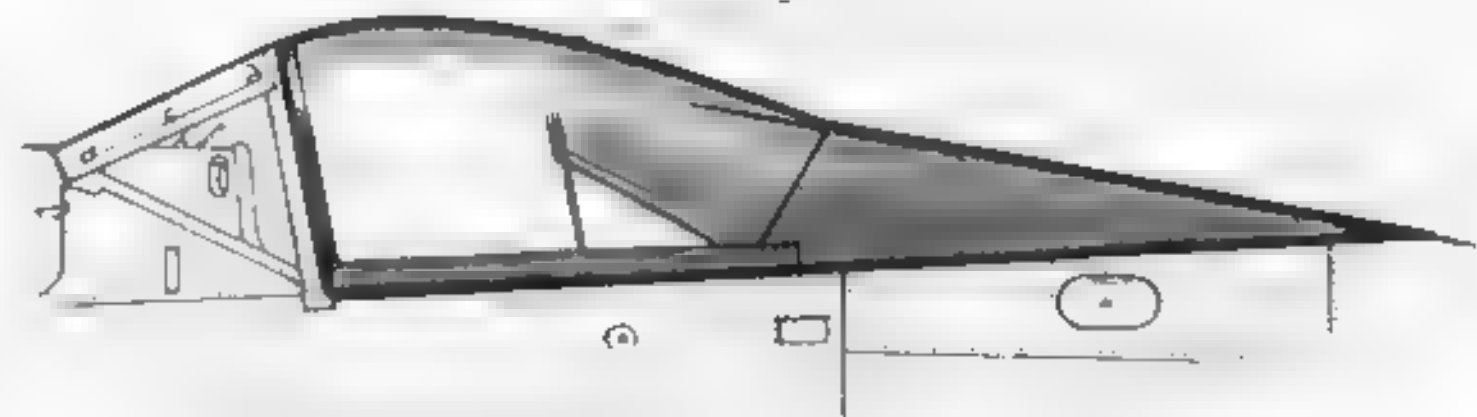
The 'flat' canopy was used on Fw 190s from its service introduction in 1941 until the end of World War II in 1945. Several small variations of this canopy occurred during production. The 'blown hood' canopy was introduced in mid-1944 for ground attack-configured Fw 190Fs and Gs. The blown canopy featured two-piece port and starboard Plexiglas sections, which was easier to produce than the earlier 'flat' style and provided better pilot visibility. The 'blown' canopy may be seen on almost any model Fw 190 from late 1944 to the end of the war.

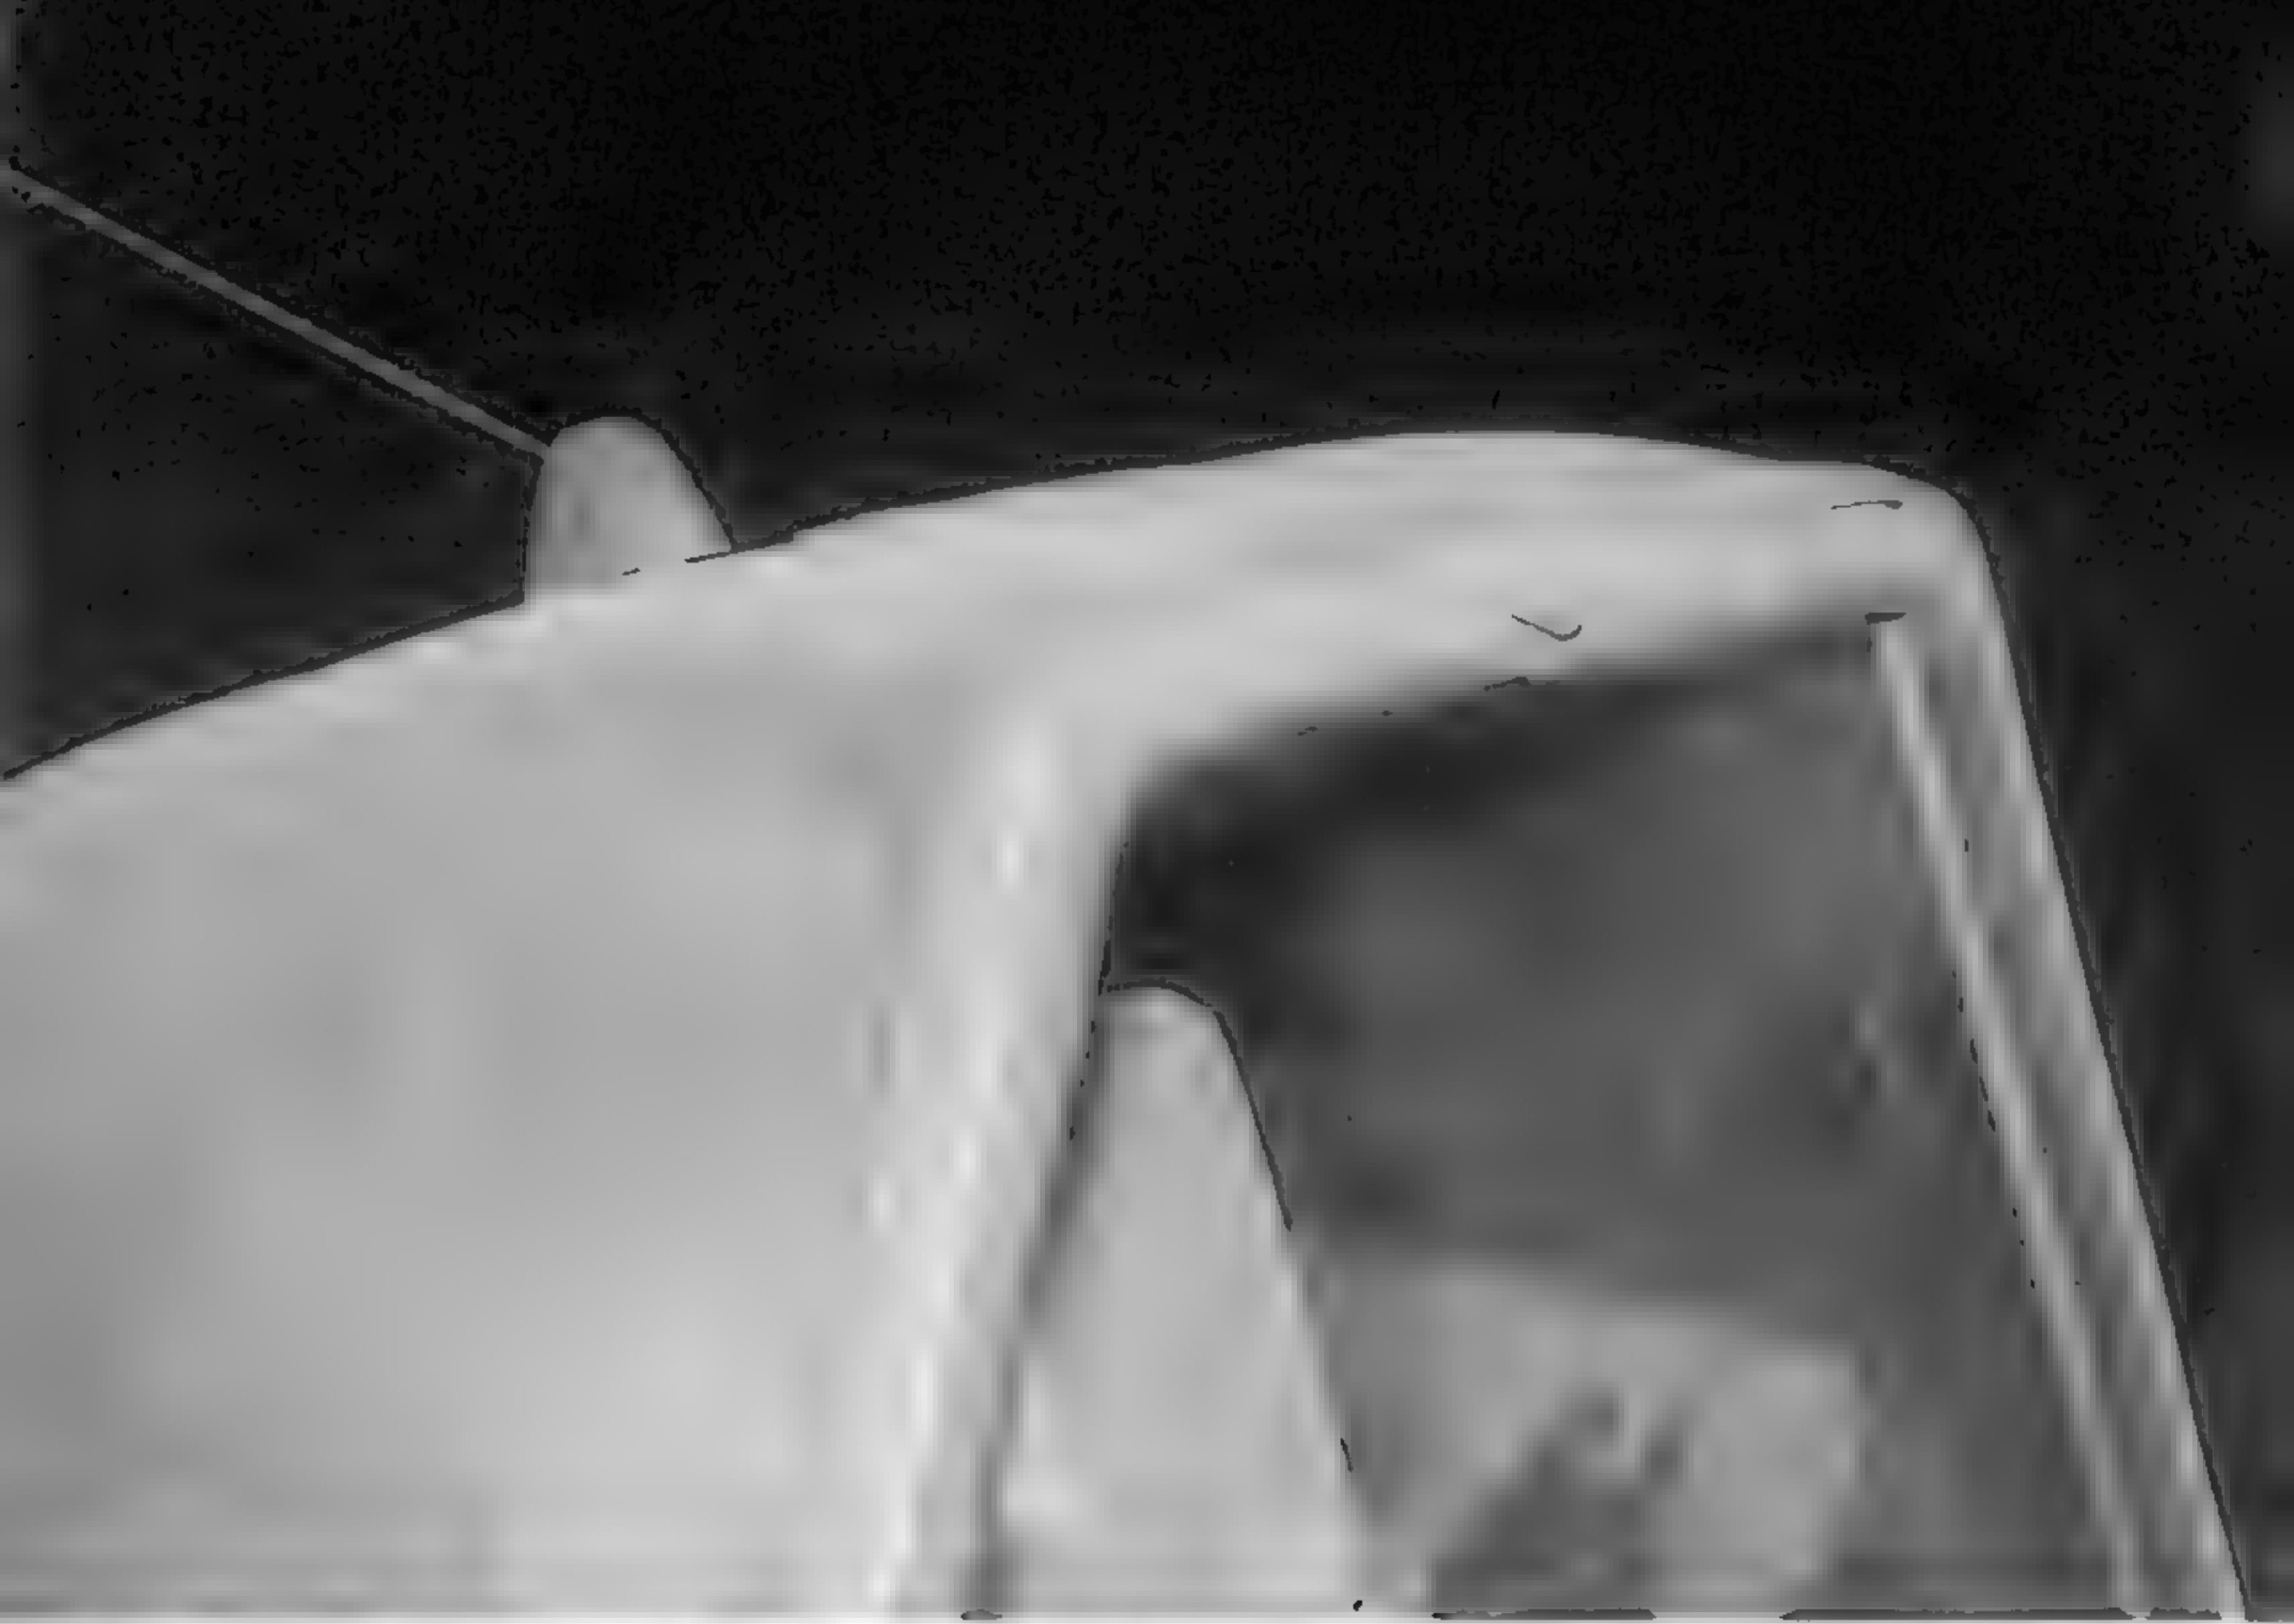
The rubber canopy seal is basically intact on this partially restored Fw 190A-6 canopy. The canopy spike protruding from the upper section of the canopy edge secures the canopy to the armored windshield. The metal exterior of the canopy front edge is connected to a piano hinge at the top to allow the Plexiglas to flex when opened or closed. (Molnar &

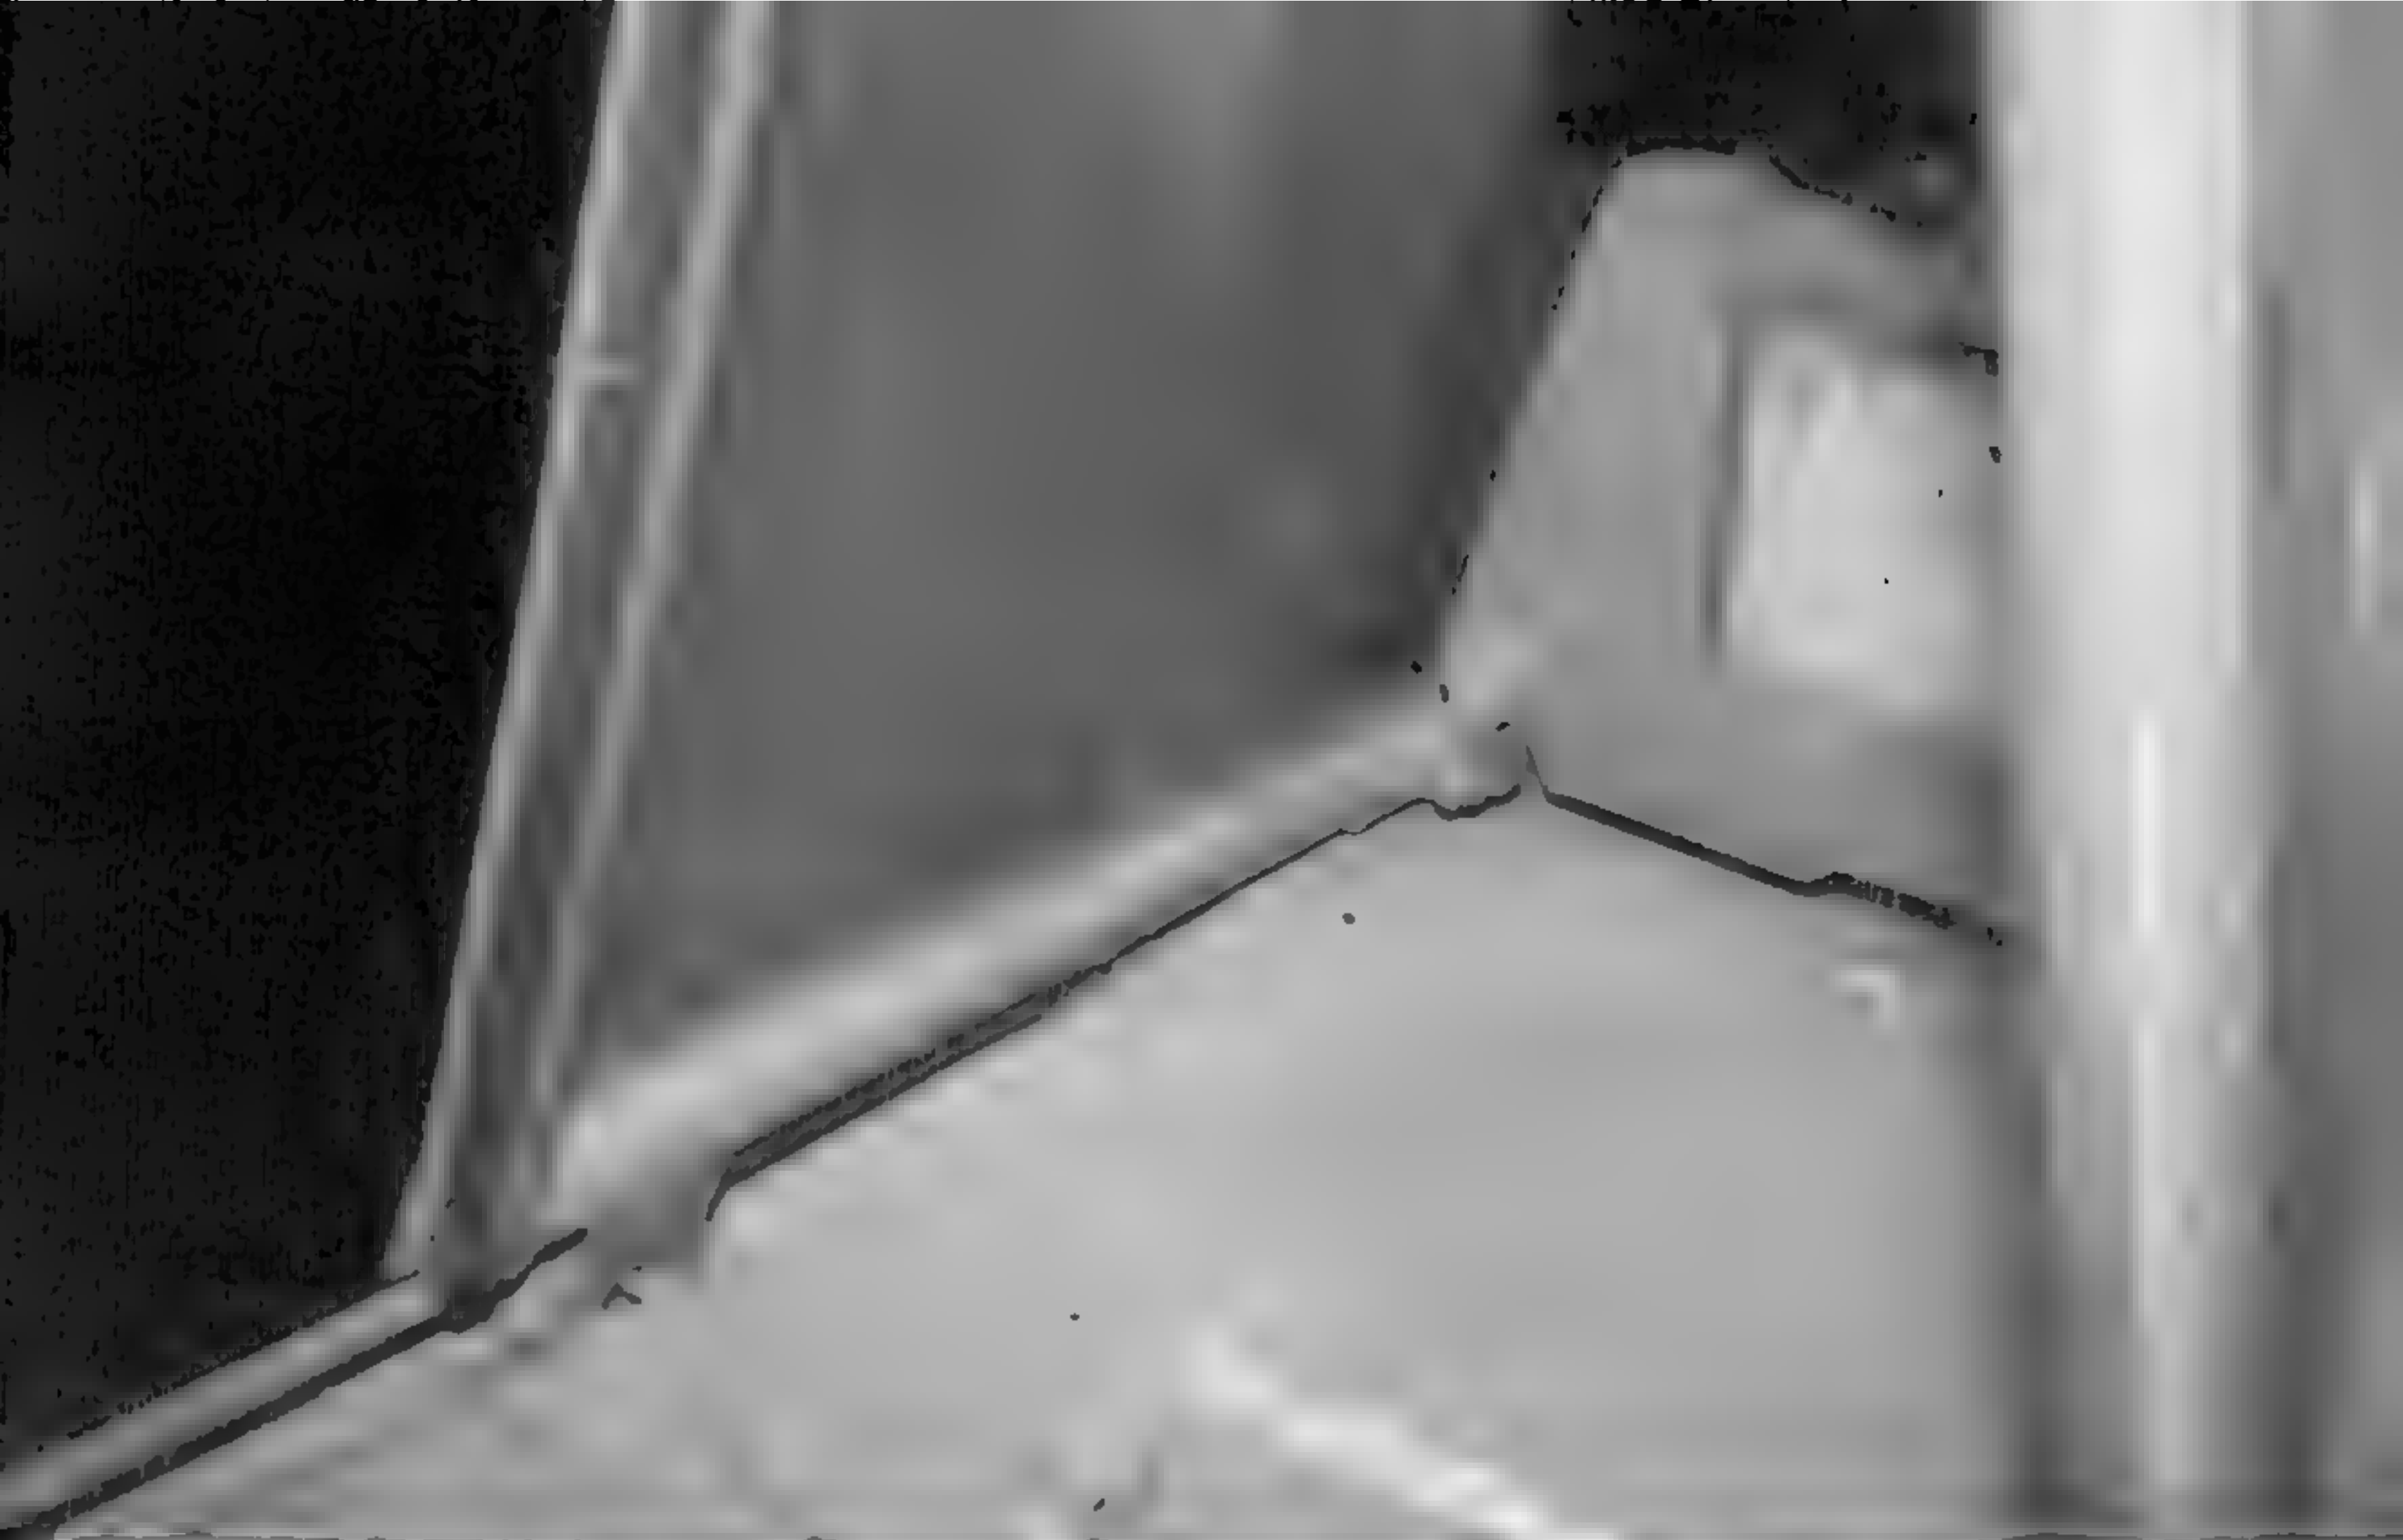
The canopy opened approximately three inches (7.6 cm) past the seat's armored backplate. This position was controlled by the number of teeth on the canopy crank operated by the pilot. Screws attached the external canopy frame to the tubular internal frame. The forward roller is attached to the canopy drive section and glides inside the fuselage canopy channel. (Molnar & Hugo)

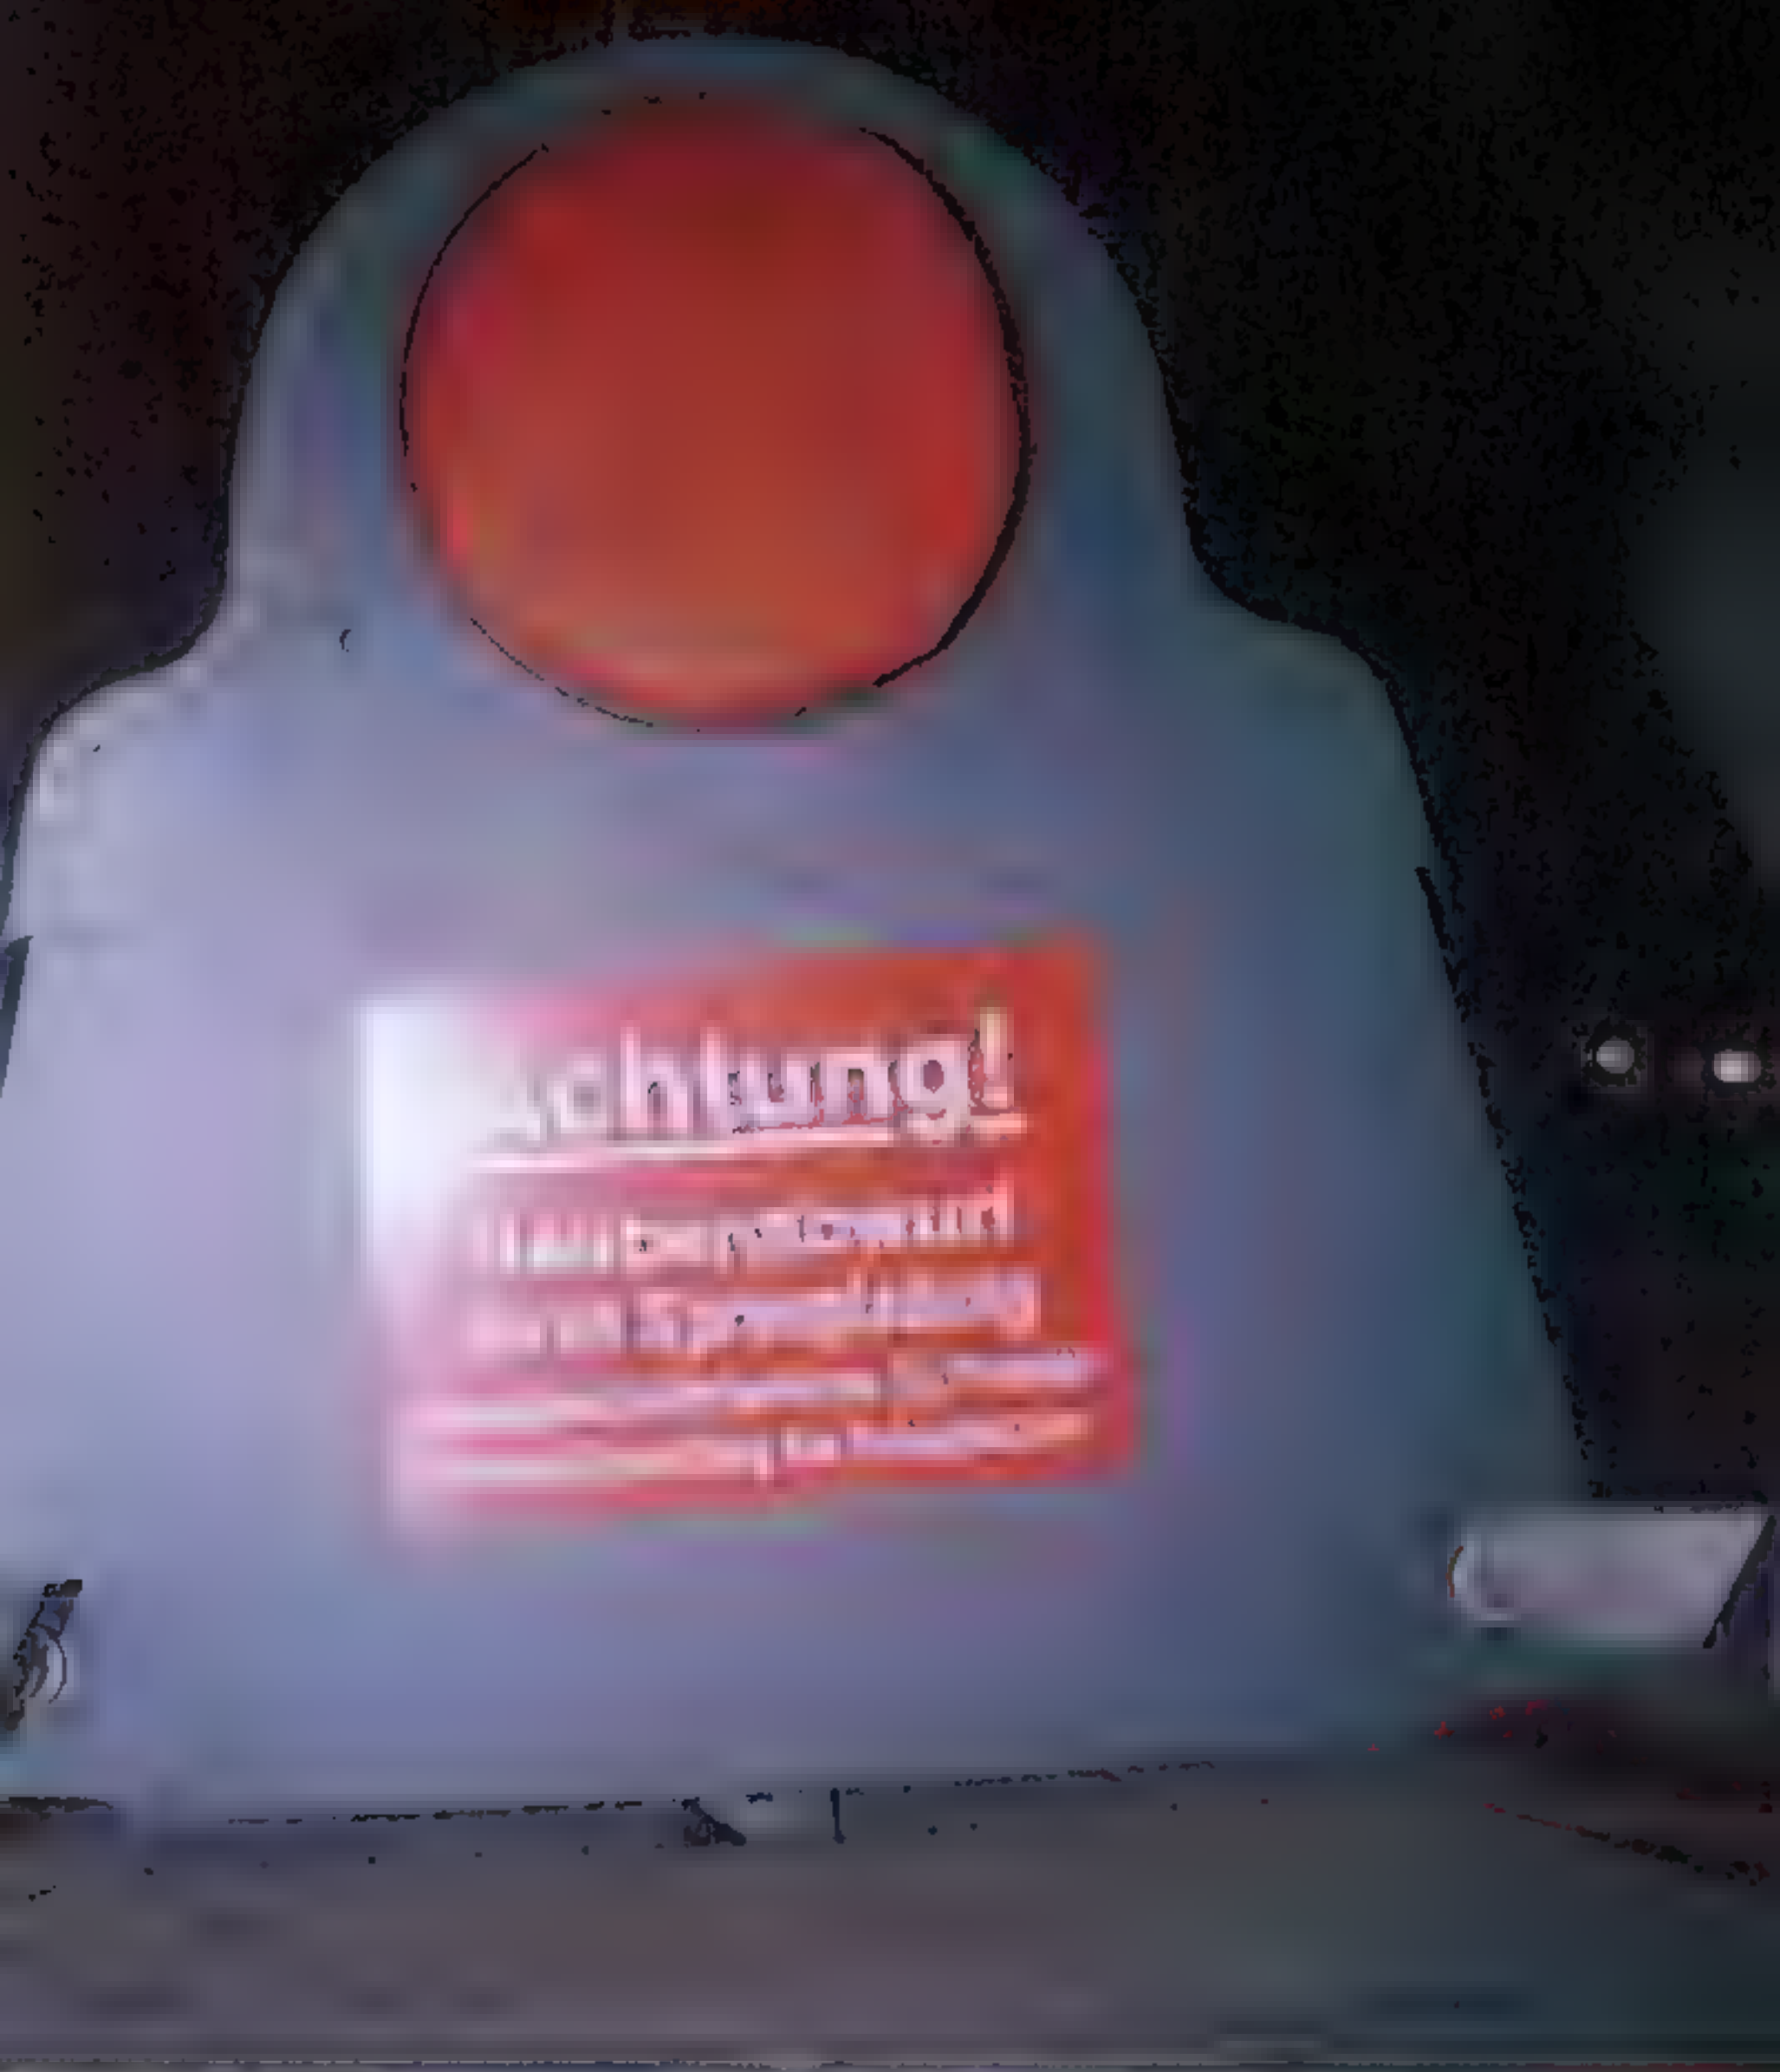
This Fw 190F-8 armored headrest was made in three sections: A bottom armored plate, a stamped sheet metal cover at the top, and a front cover with headrest. Two simple late war pivot mounts attached the lower armored plate to the canopy bottom. The English translation of the placard reads: Attention! Release of the canopy by explosive charge. Do not touch release lever. In case of a test first secure the striker. (Ryle)

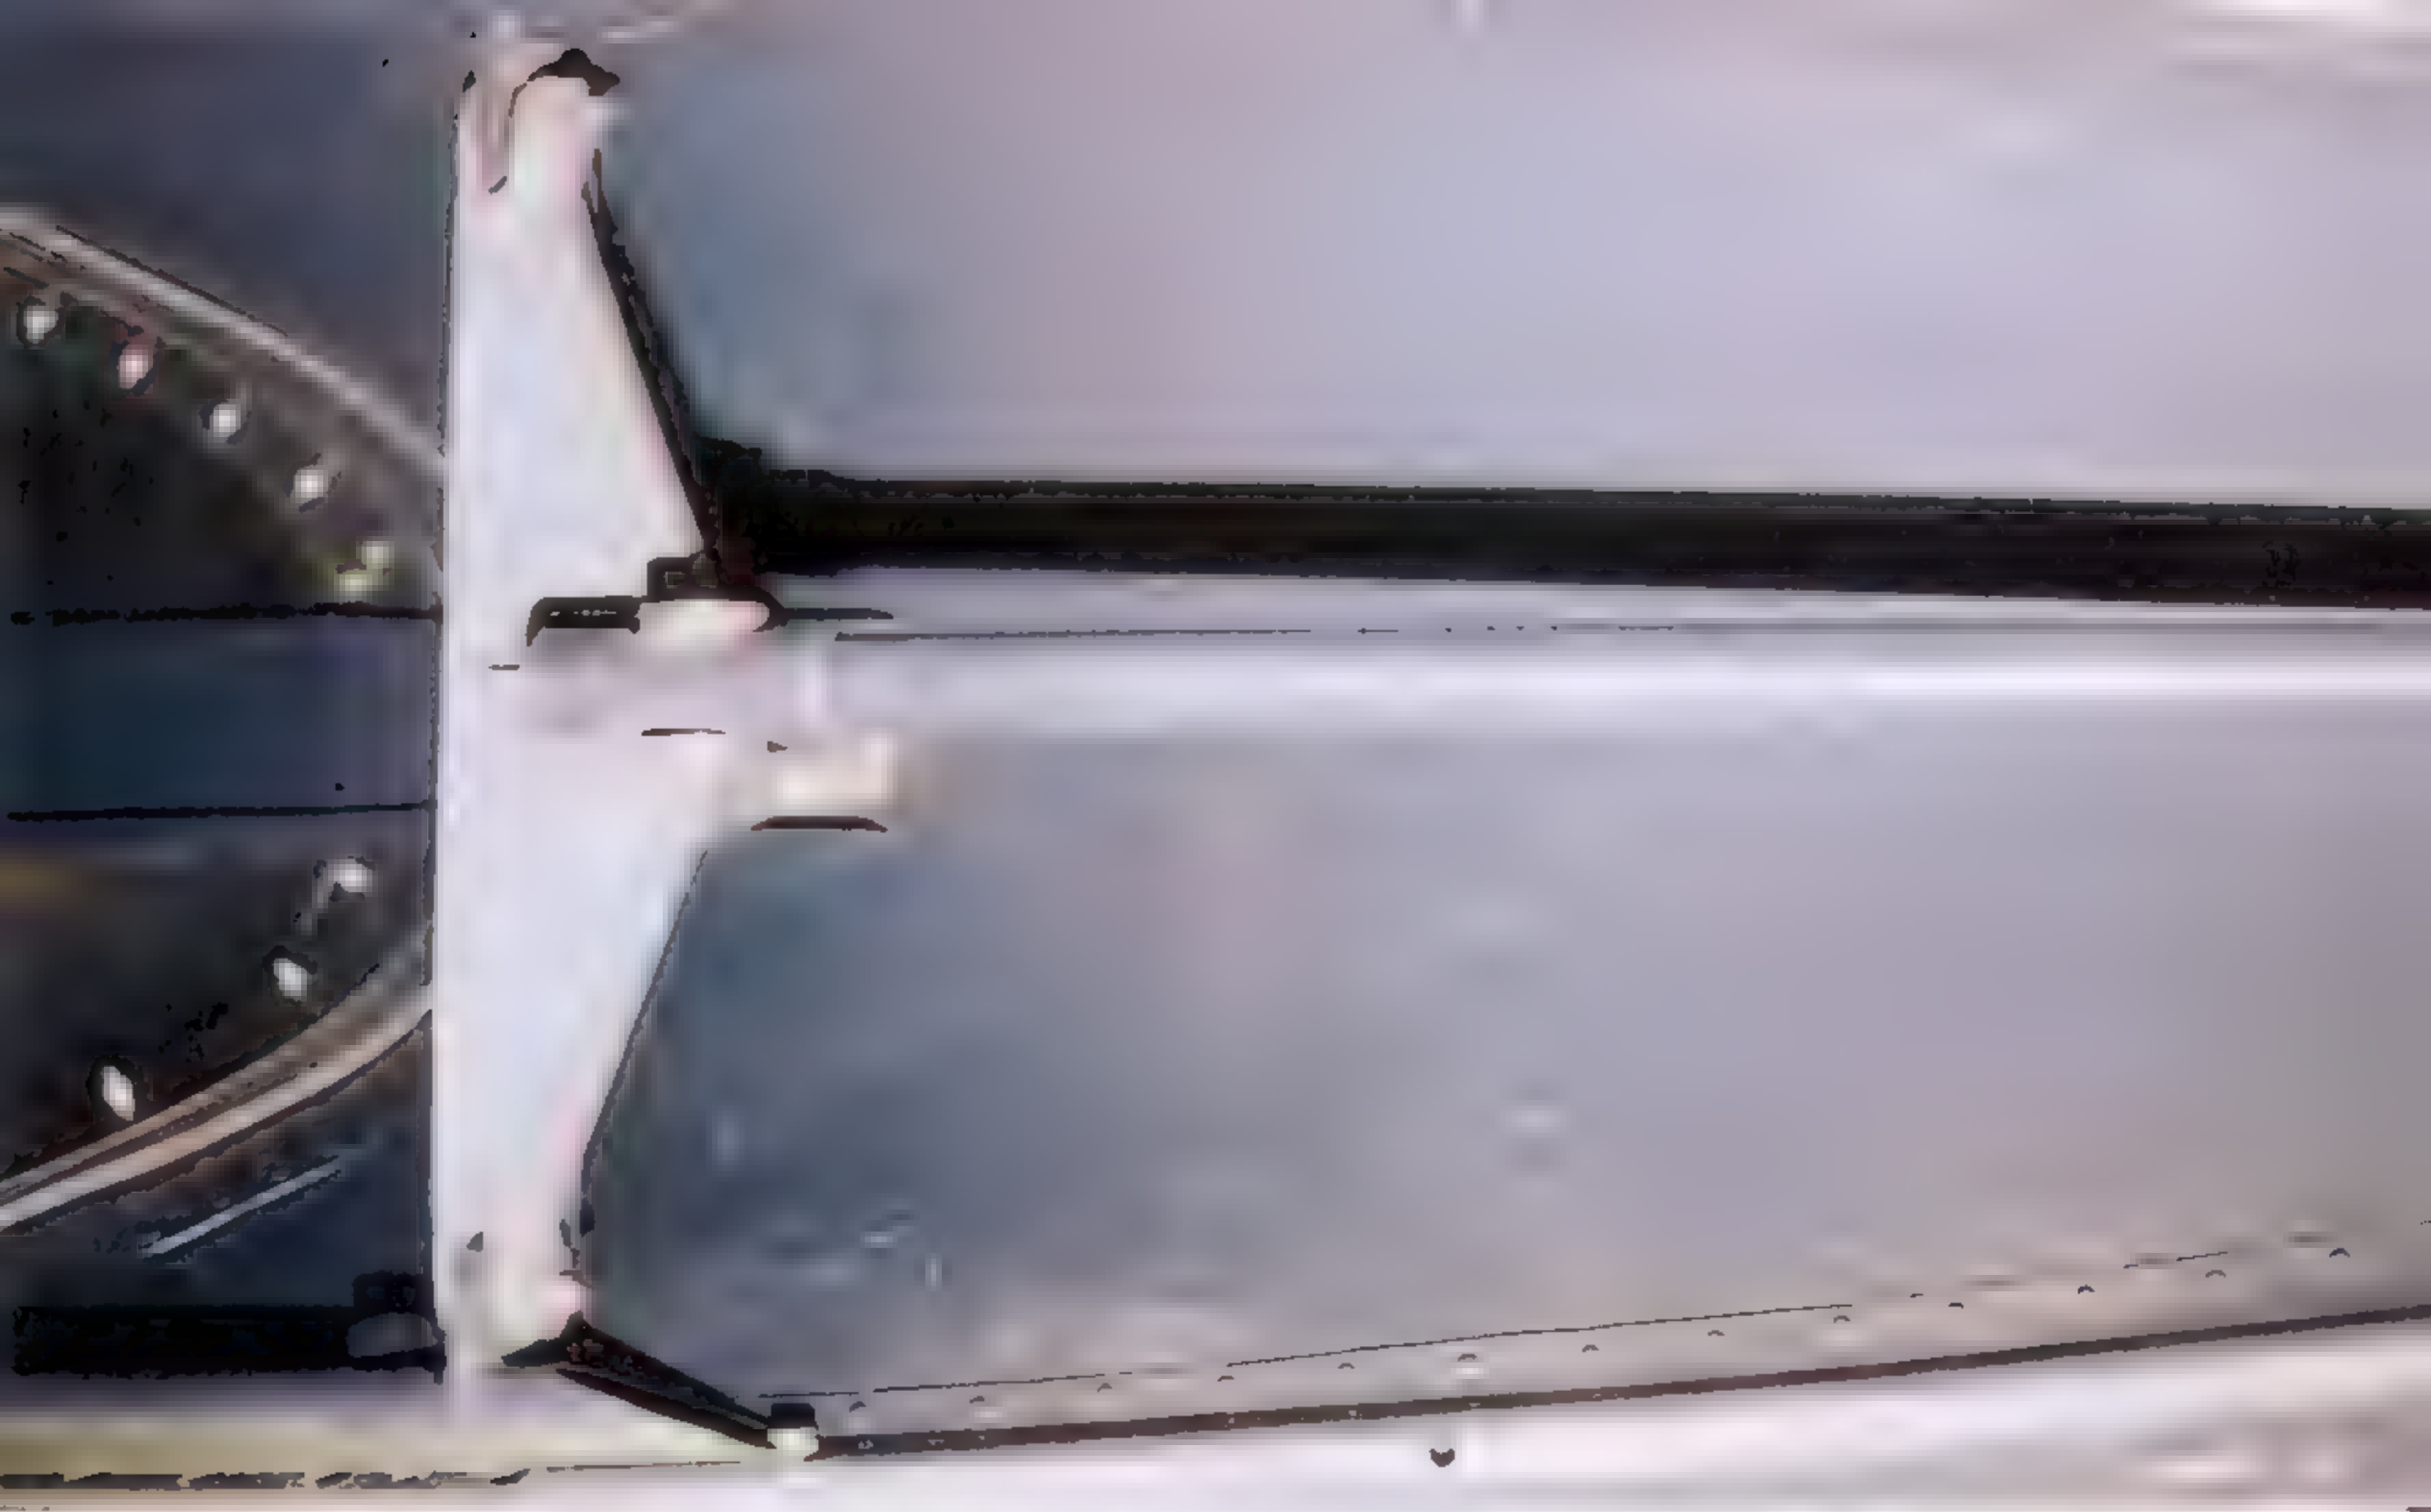
The outer canopy ejection tube ran along the bottom of the Fw 190 'flat' canopy and was attached to the cross bracing located at the aft end of the canopy's tubular frame. This cross bracing was the attachment point for the upper support and lateral wire supports of the armored headrest. The aft end of the tubular frame is attached to the formed metal internal canopy bracing. (Laing)

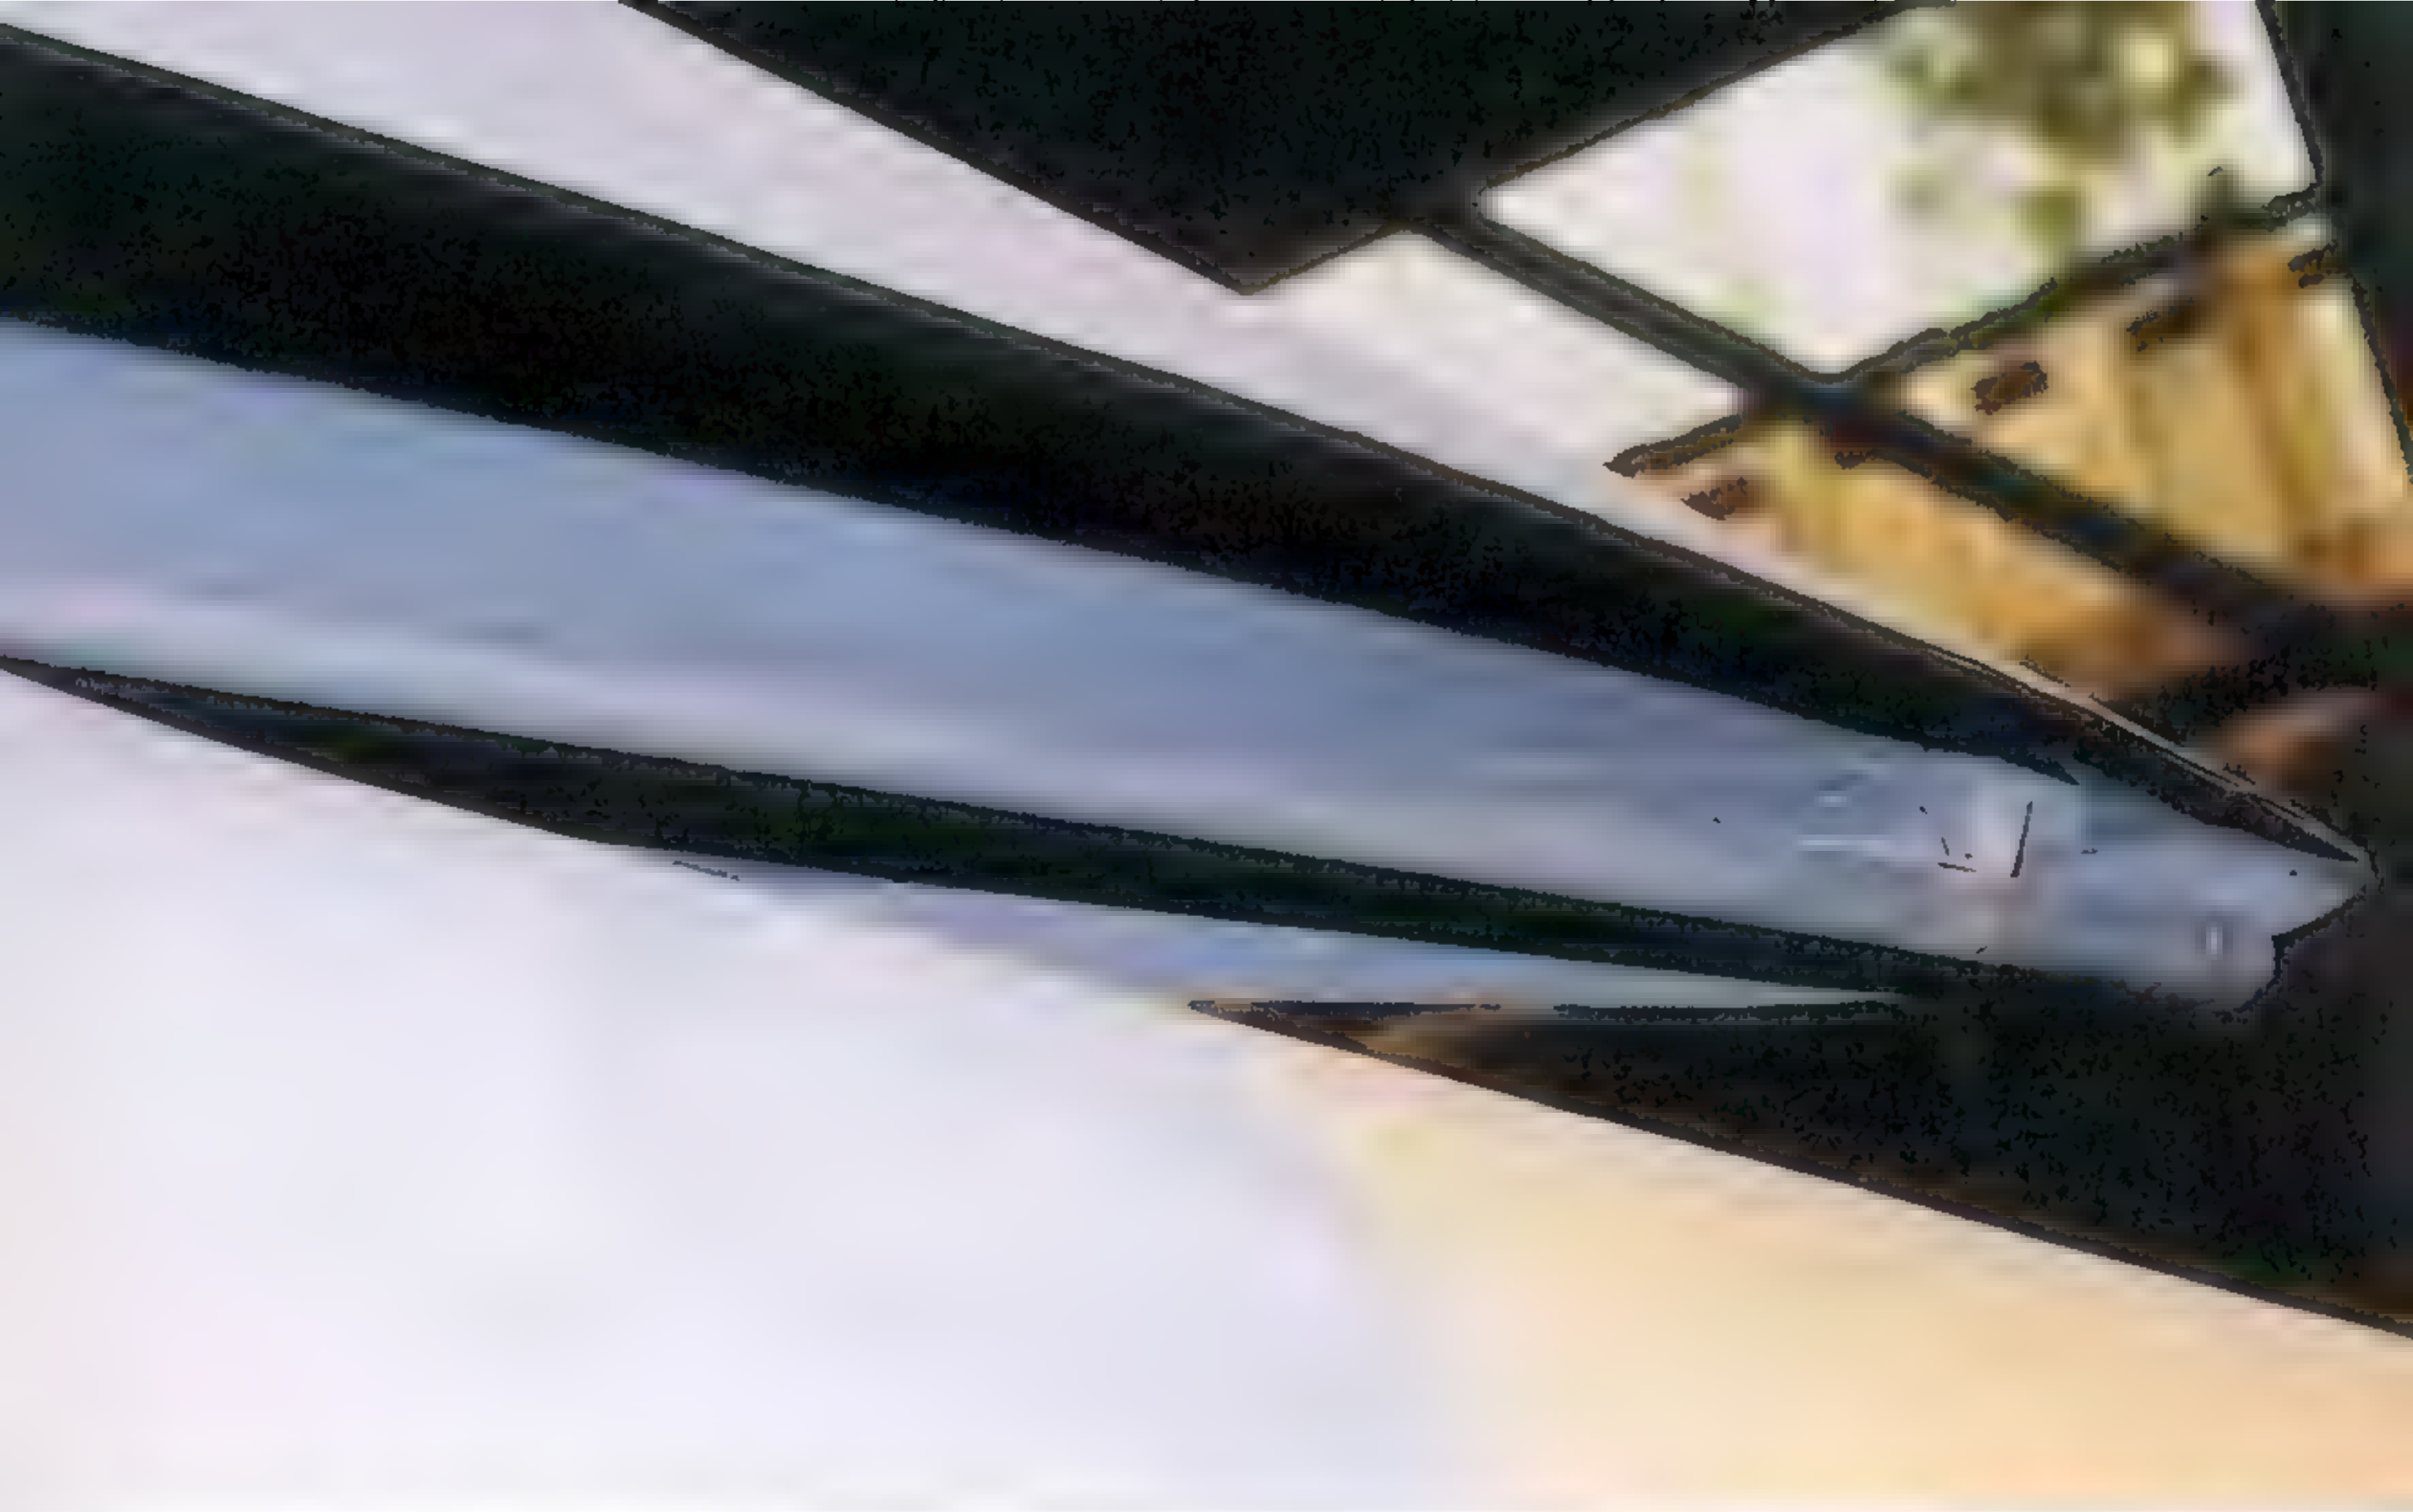
The outer firing tube and its attachment point protrude from the opened Fw 190A-6 canopy. This tube fitted over the inner firing tube, which contained a 26mm flare gun blank for an explosive charge. The charge was located behind the pilot's seat and activated by pressing the jettison lever on the canopy drive unit in the cockpit. This lever released a firing pin and the channeled explosion propelled the canopy rearward off the aircraft. (Molnar & Hugo)
